## 08 - ENVIRONMENTAL DISASTER IN MINAS DO CAMAQUÃ, RIO GRANDE DO SUL, BRAZIL: A REVIEW

Ano 6 (2019) - Número 3

Claudete Gindri Ramos<sup>a</sup>,

Marcondes Lima da Costa<sup>b</sup>

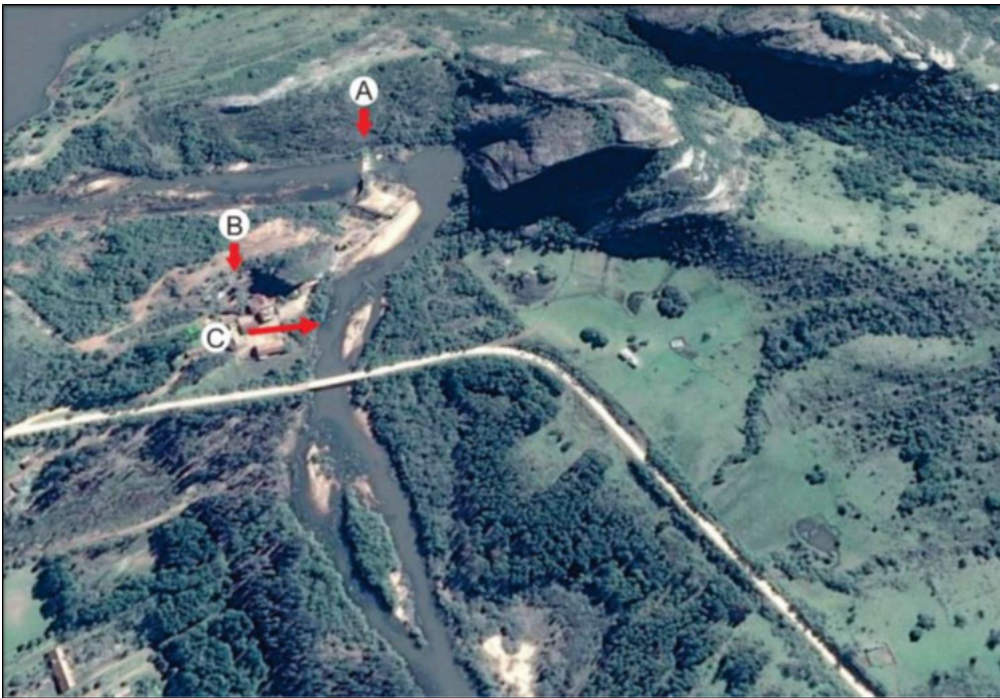
Due to the use of new technologies for the exploration of ores, an ore concentration plant and a dam were built in the João Dias stream, which would be used to install an electric power generation turbine (Harres 2000). From 1981 onwards, the disposal of tailings from the Camaquã Mines, which until the year 1980 was improperly carried out on the banks of the João Dias stream and around Morro da Cruz, began to be carried out in a dam built in a meander of the state. João Dias stream course (Ronchi and Lobato 2000). Figure 2 shows how the tailings disposal was carried out in the João Dias stream until 1981.

Figure 2. A: Tailings dam; B: Concentration plant; C: Waste path towards João Dias stream. Source: Von Ahn (2018).

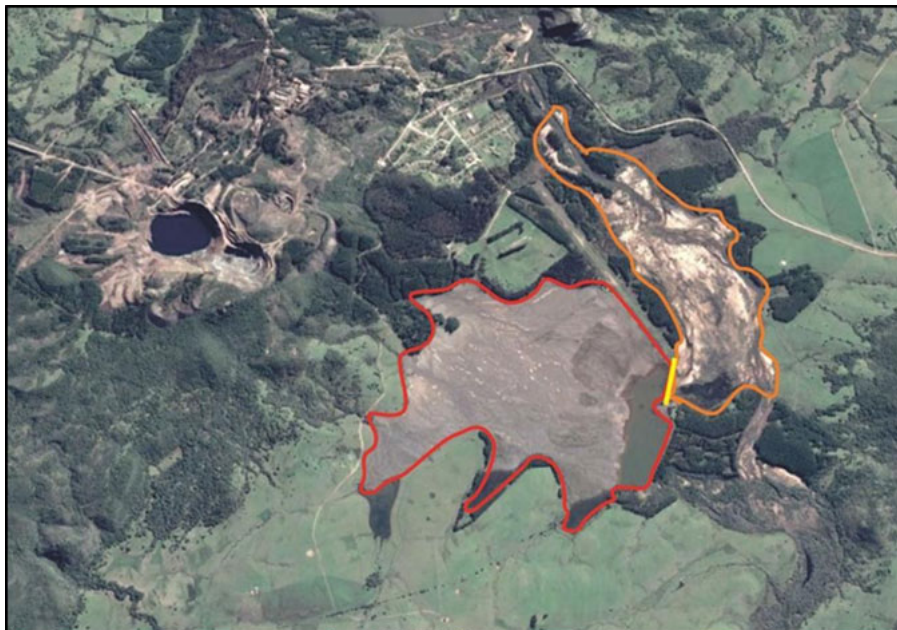
In 1981, several tailings spills occurred, the most significant in relation to sediment dispersion occurred on November 24 this year, due to the partial breakage of the tailings dam's northern dam (Fernsterseifer and Hansen 2000).

Many surveys were conducted to ascertain the causes of the incident and all point to the obstruction of intermittent tributaries by the tailings dam, which under the heaviest rainfall conditions did not find a discharge valve and accumulated the rainfall load at its single spillway. Since it was not sized for large volumes of water, the rupture occurred, even though at the time the dam had few tailings compared to its capacity (Figure 3) (CBC 1984).

Figure 3. Tailings dam (red), ruptured mud (yellow) and ejected material in the João Dias stream (orange). Source: Google Earth (2019).

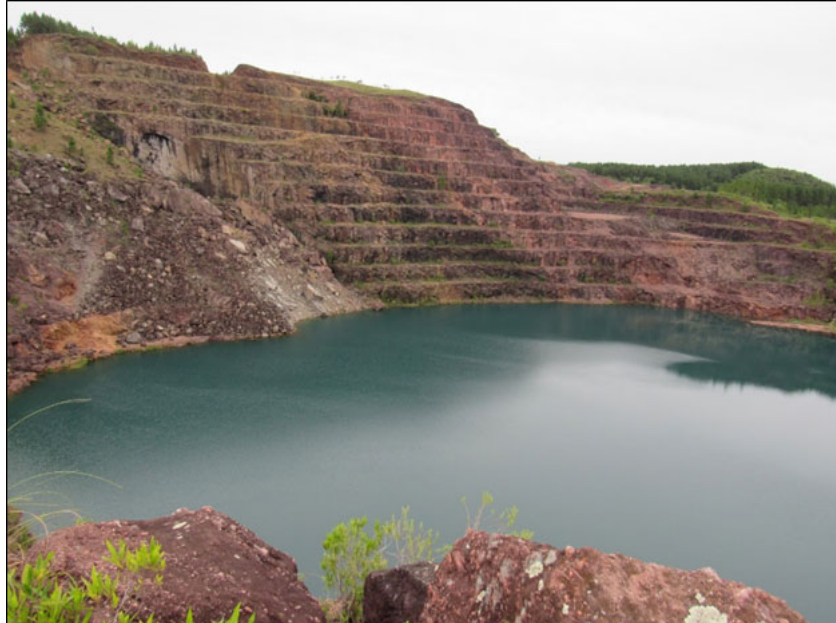
Deactivated open pit digs depict the marks of the exploration past, which are well defined in geographical space, as a result of a process of de-characterization of local natural cover (Figure 4).

Figure 4. Inactive open pit in the Camaquã Mines. Source: Google Earth (2019).  
<https://earth.google.com/>.

Figure 4 shows that a large volume of rocks is exposed to oxidation processes, can generate acid drainages (AMD) with adverse effects on surface and groundwater quality (Figueiredo 2000).

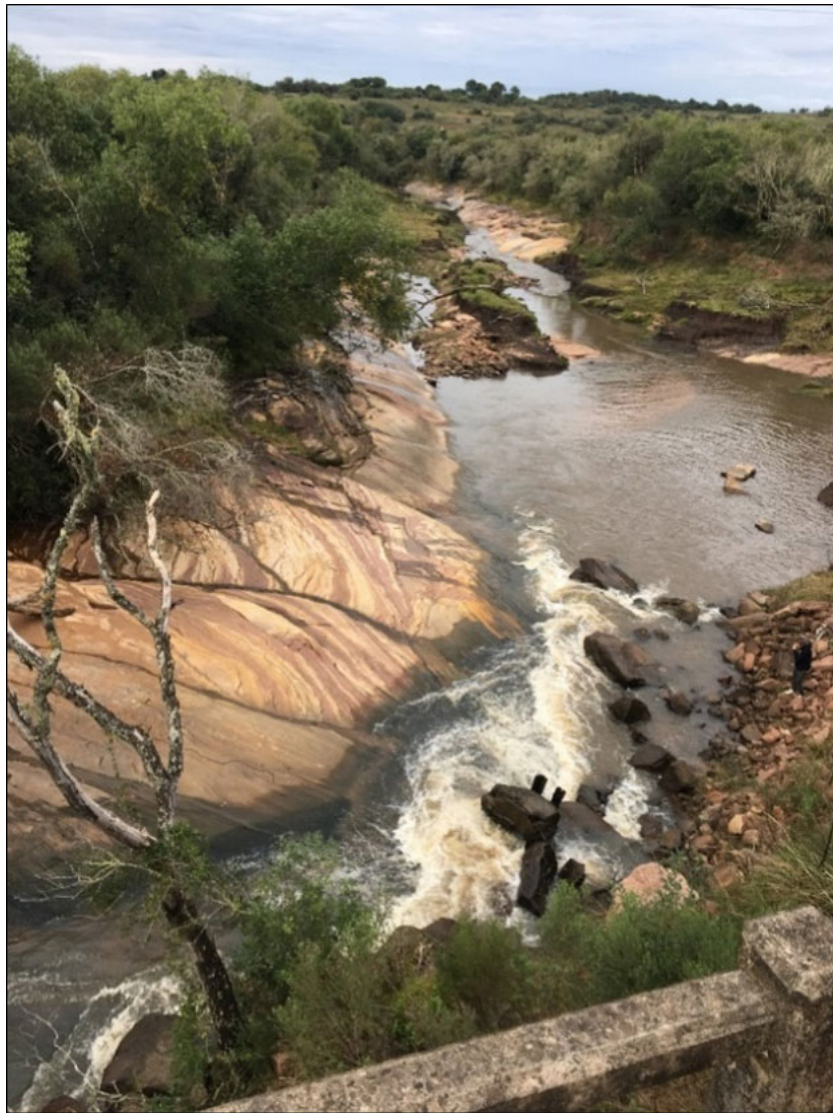
The rock substratum of the João Dias stream is shown in Figure 5. The visual observation made in May 2019 showed that the area is composed of clastic sedimentary and volcanic rocks of the Camaquã Basin.

Figure 5. A view of João Dias stream showing the domain of clastic sedimentary rocks and fragments of these rocks.

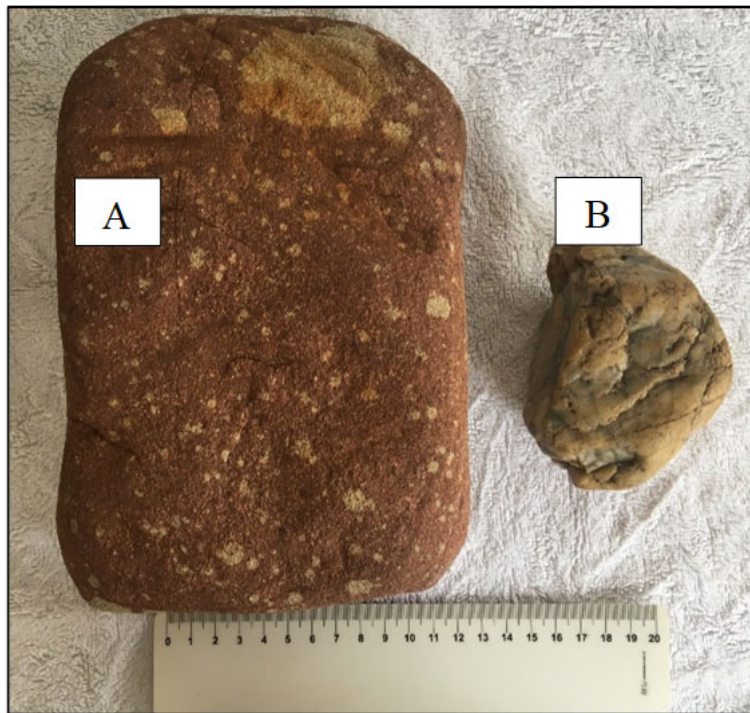
Figure 6. Samples of A: rock pebble; and B: milky quartz, collected at the João Dias stream.

The stream pebbles comprise granite, gneiss, subordinately quartz, quartzite, and reddish sandstone (Figure 6).
